Manhole Inspection Summary

Manhole # S37M__010MH

Inspection ☐ Is Incomplete Rating: **3) Fair**

Location Address: **801 key hw**

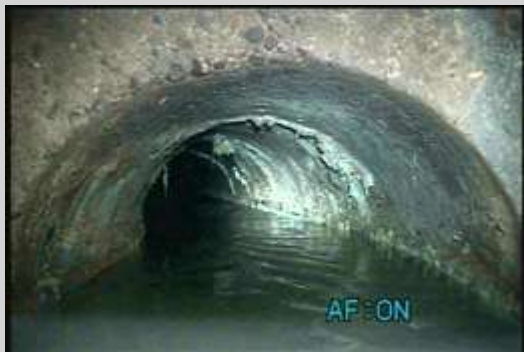
12 O'Clock Outflow

30 in. Circular Gravity Sewer
Pipe Out @ 12 O'Clock

Pipe Material: **Clay** ☐ Pipe Lined

Invert Depth: 12.50 (ft.) Flow Characteristics: **Slow**

Infiltration: **None** Pipe Seal Cond: **Unknown**

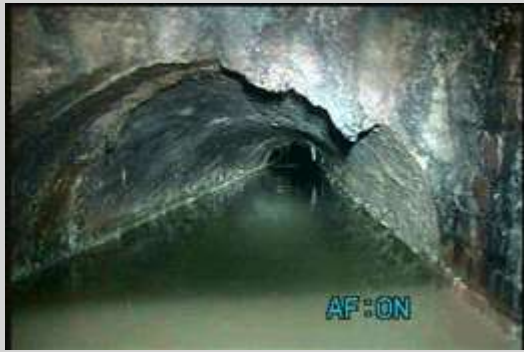
6 O'Clock Inflow

30 in. Circular Gravity Sewer
Pipe In @ 6 O'Clock

Pipe Material: **Clay** ☐ Pipe Lined

Invert Depth: 12.33 (ft.) Flow Characteristics: **Slow**

Infiltration: **None** Pipe Seal Cond: **Unknown**

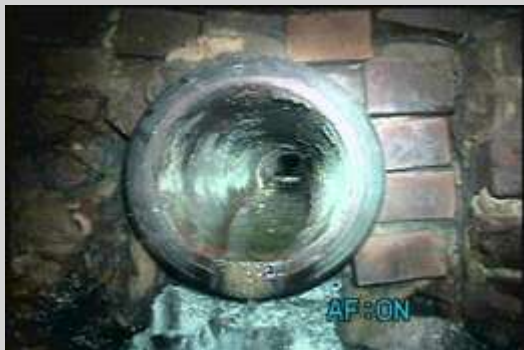
9 O'Clock Inflow

8 in. Circular Gravity Sewer
Pipe In @ 9 O'Clock

Pipe Material: **Clay** ☐ Pipe Lined

Infiltration: **None** Pipe Seal Cond: **Unknown**
